# Manhole Inspection Summary

Manhole # S59G\_\_009MH

Insp Date: **7/23/08 9:44 AM**

**Location** Address: **300 s lehigh st**

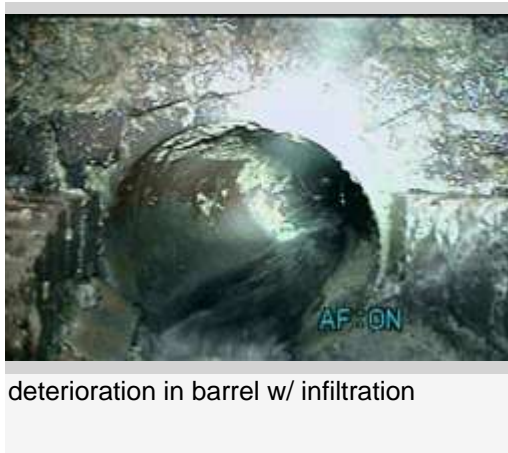
Defect 3

Condition: ☐ Sound ☐ Cracked ☐ Root Intrusion ☐ Loose Brick ☒ **Deteriorated**

Infiltration: ☐ None ☐ Joint ☐ Cracks ☐ Mortar ☐ Roots ☒ **Wall**

deterioration in barrel w/ infiltration

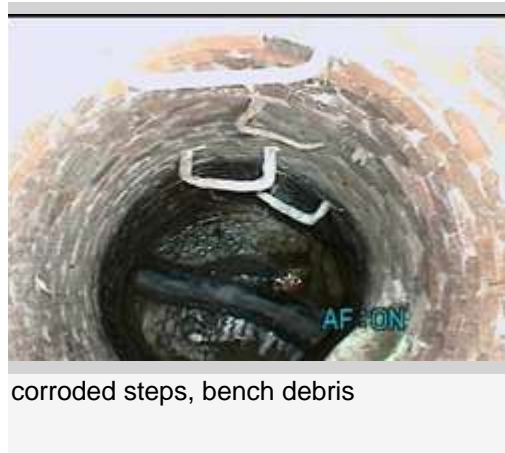
Defect 2

Condition: ☐ Sound ☐ Cracked ☐ Root Intrusion ☐ Deteriorated ☐ Leaks ☒ **Debris**

Count: **6** Missing: **2** ☒ **Corroded**

corroded steps, bench debris

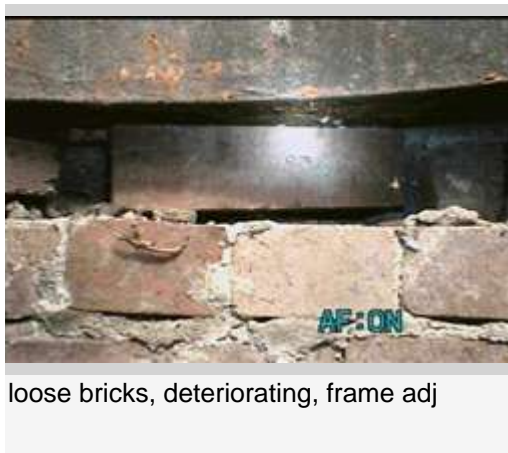
Defect 1

Condition: ☐ Sound ☐ Cracked ☐ Root Intrusion ☒ **Loose Brick** ☒ **Deteriorated**

loose bricks, deteriorating, frame adj

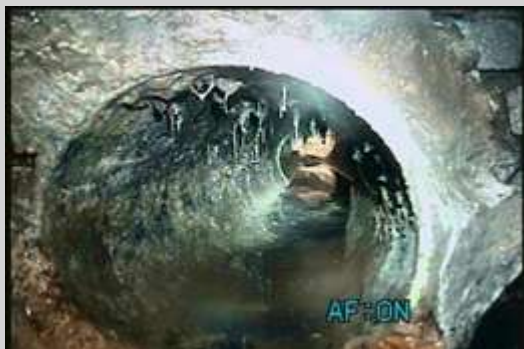
5 O'Clock Inflow

Deposits: ☐ None ☐ Mud ☐ Sludge ☐ Debris ☒ Grease
